Home Report

Single Survey

Property address	8 Kemp Place Edinburgh EH3 5HU
Customer	Nicola Johnston
Customer address	8 Kemp Place Edinburgh EH3 5HU
Prepared by	Shepherd Chartered Surveyors
Date of inspection	12/09/2023

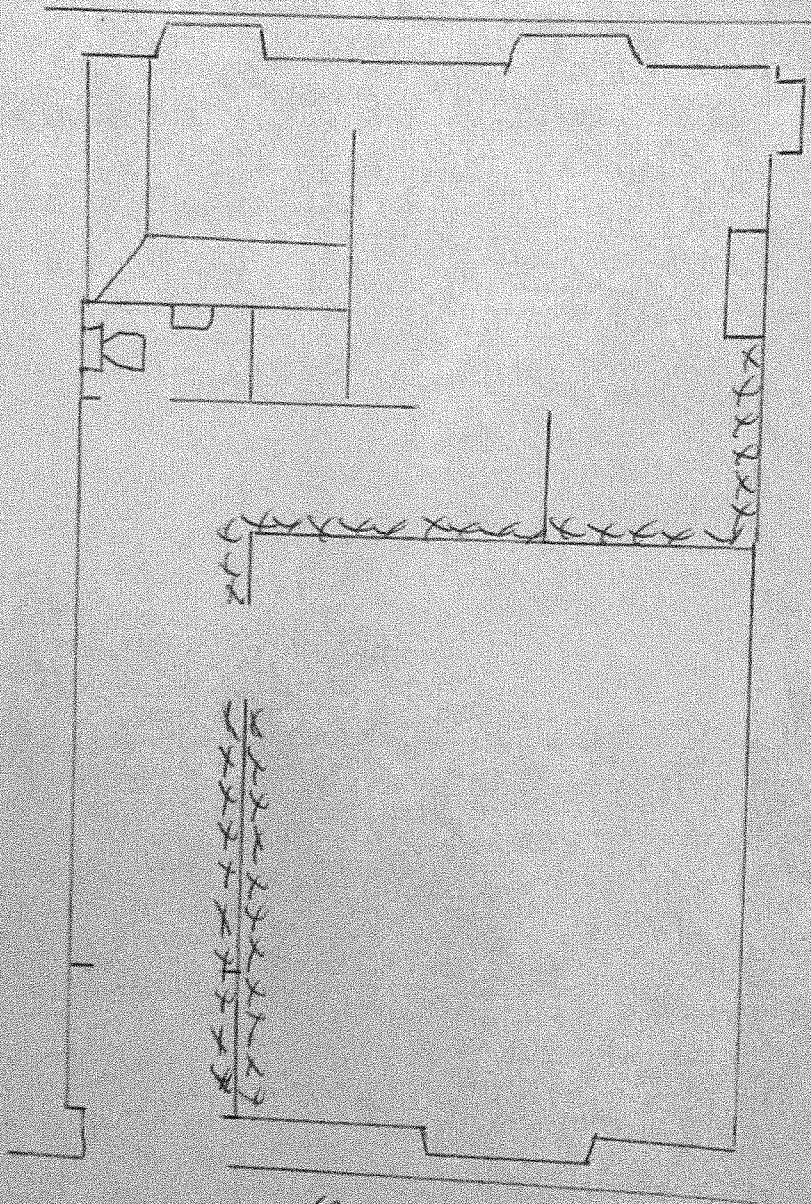
PLANK ELEVATION

X MARK WALLS TO BE TREATED FOR DAMP
AS SHOWN ON REPORT ATTACHED
