SINGLE SURVEY REPORT

PROPERTY ADDRESS	43/5 (2F2) Montgomery Street Edinburgh EH7 5JX
CLIENT	Anna Kaul
CLIENT ADDRESS	c/o Urquharts 16 Heriot Row Edinburgh EH3 6HR
DATE OF INSPECTION	27 February 2020
PREPARED BY	DIXON HEANEY KEAN KENNEDY Chartered Surveyors 54 Corstorphine Road Edinburgh EH12 6JQ Tel: 0131 313 0444 Fax: 0131 313 0555 Email: survey@dhkk.co.uk

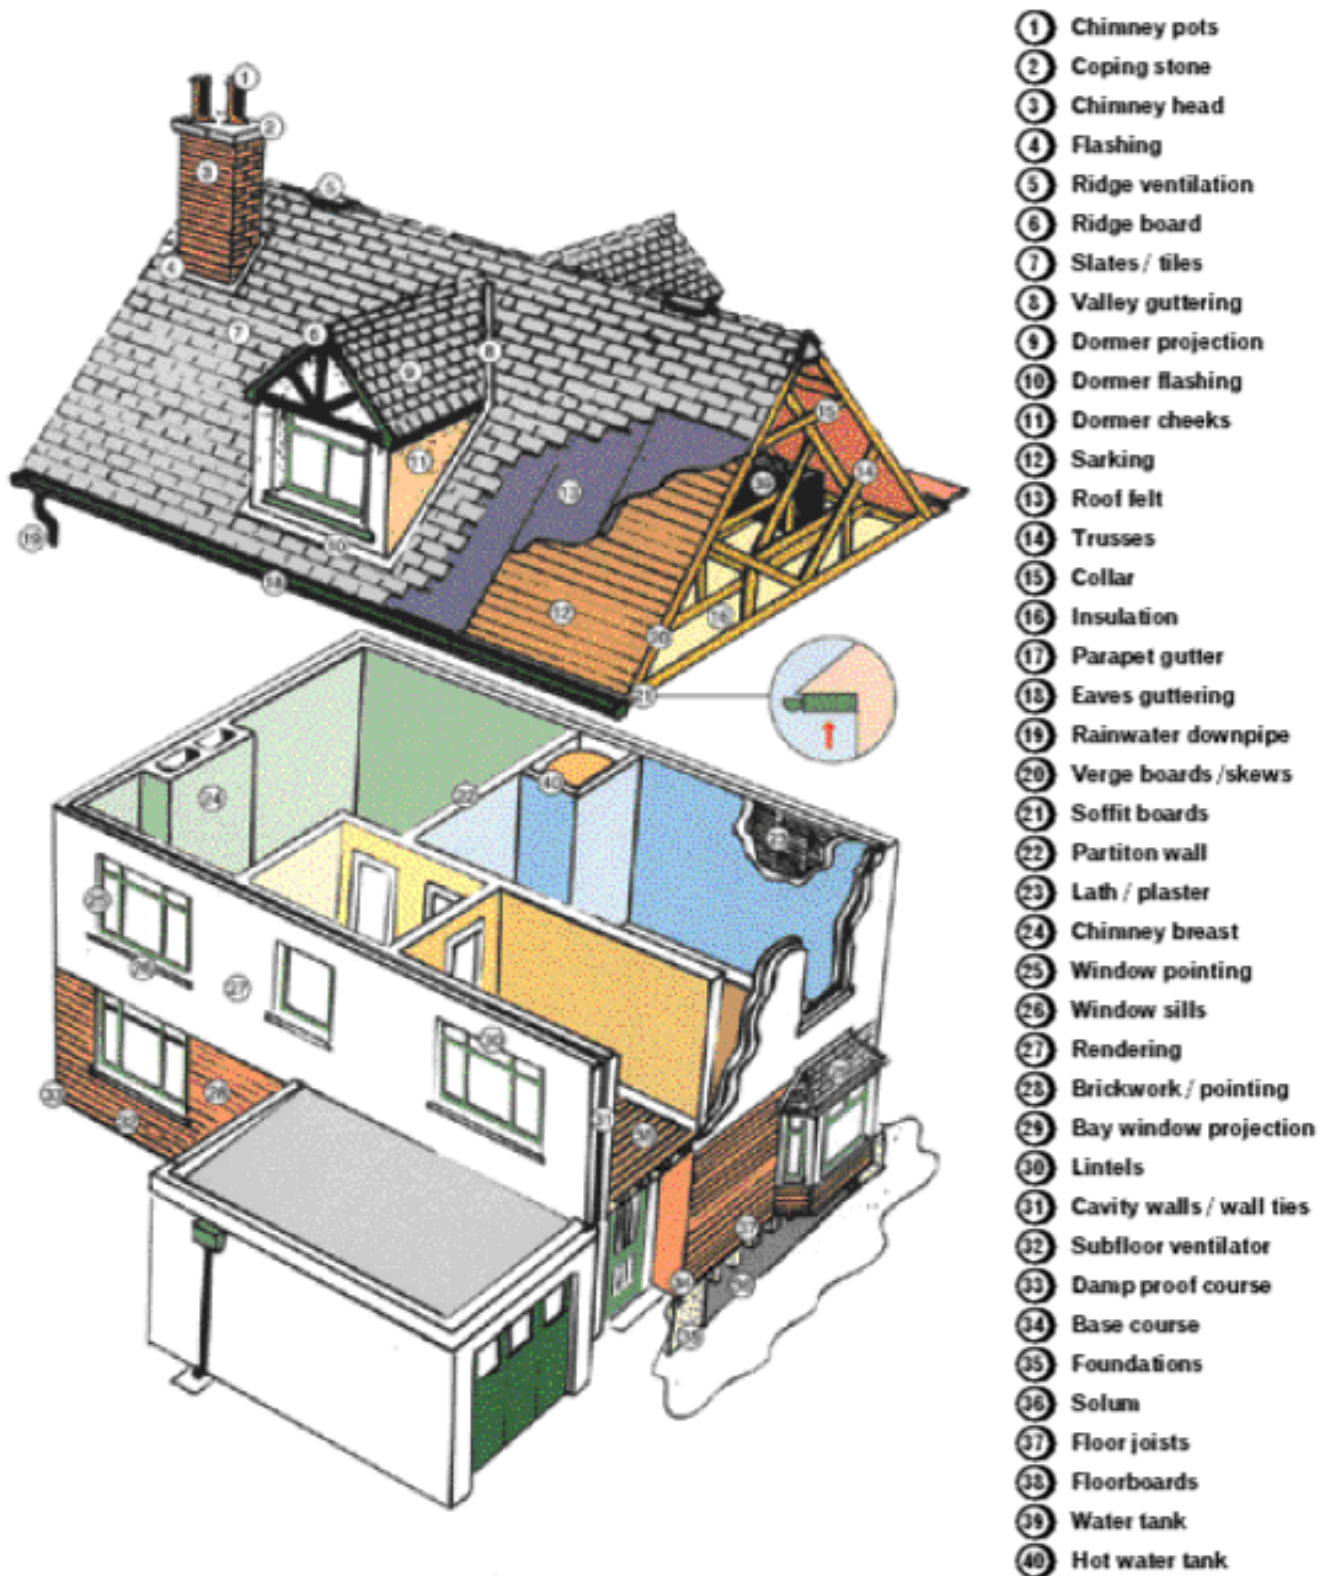
Sectional diagram showing elements of a typical house

- ① Chimney pots
- ② Coping stone
- ③ Chimney head
- ④ Flashing
- ⑤ Ridge ventilation
- ⑥ Ridge board
- ⑦ Slates / tiles
- ⑧ Valley guttering
- ⑨ Dormer projection
- ⑩ Dormer flashing
- ⑪ Dormer cheeks
- ⑫ Sarking
- ⑬ Roof felt
- ⑭ Trusses
- ⑮ Collar
- ⑯ Insulation
- ⑰ Parapet gutter
- ⑱ Eaves guttering
- ⑲ Rainwater downpipe
- ⑳ Verge boards /skews
- ㉑ Soffit boards
- ㉒ Partiton wall
- ㉓ Lath / plaster
- ㉔ Chimney breast
- ㉕ Window pointing
- ㉖ Window sills
- ㉗ Rendering
- ㉘ Brickwork / pointing
- ㉙ Bay window projection
- ㉚ Lintels
- ㉛ Cavity walls / wall ties
- ㉜ Subfloor ventilator
- ㉝ Damp proof course
- ㉞ Base course
- ㉟ Foundations
- ㊱ Solum
- ㊲ Floor joists
- ㊳ Floorboards
- ㊴ Water tank
- ㊵ Hot water tank

Reference may be made in this report to some or all of the above component parts of the property. This diagram may assist you in locating and understanding these terms.

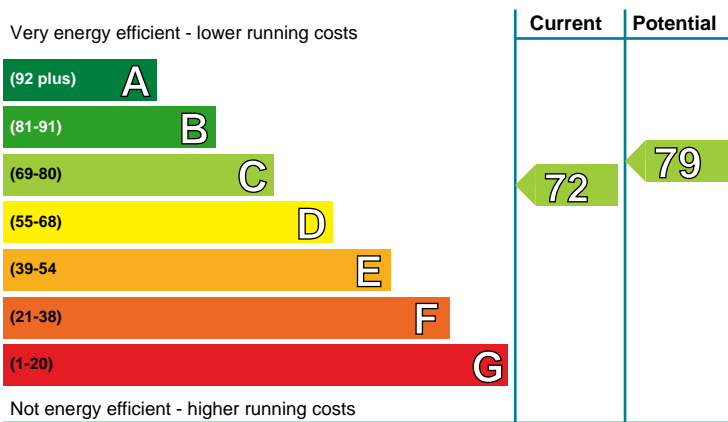
Energy Efficiency Rating

This graph shows the current efficiency of your home, taking into account both energy efficiency and fuel costs. The higher this rating, the lower your fuel bills are likely to be.

Your current rating is **band C (72)**. The average rating for EPCs in Scotland is **band D (61)**.

The potential rating shows the effect of undertaking all of the improvement measures listed within your recommendations report.

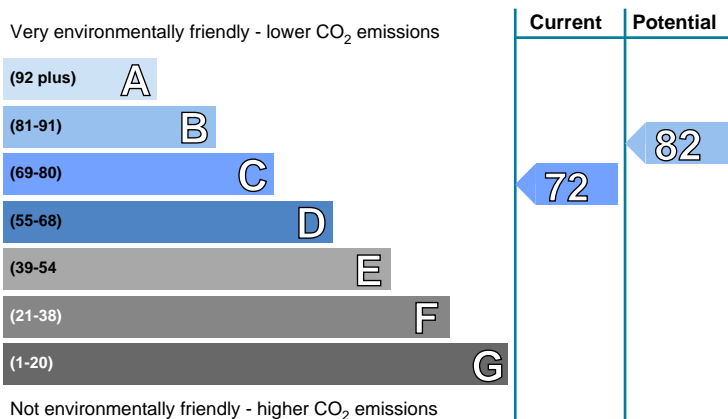
Environmental Impact (CO₂) Rating

This graph shows the effect of your home on the environment in terms of carbon dioxide (CO₂) emissions. The higher the rating, the less impact it has on the environment.
