SINGLE SURVEY REPORT

PROPERTY ADDRESS	74 Marionville Avenue Edinburgh EH7 6AY
CLIENT	The Executry of Brenda Borthwick
CLIENT ADDRESS	c/o Urquharts Solicitors 16 Heriot Row Edinburgh EH3 6HR
DATE OF INSPECTION	26 th January 2021
PREPARED BY	DIXON HEANEY KEAN KENNEDY Chartered Surveyors 54 Corstorphine Road Edinburgh EH12 6JQ Tel: 0131 313 0444 Fax: 0131 313 0555 Email: survey@dhkk.co.uk

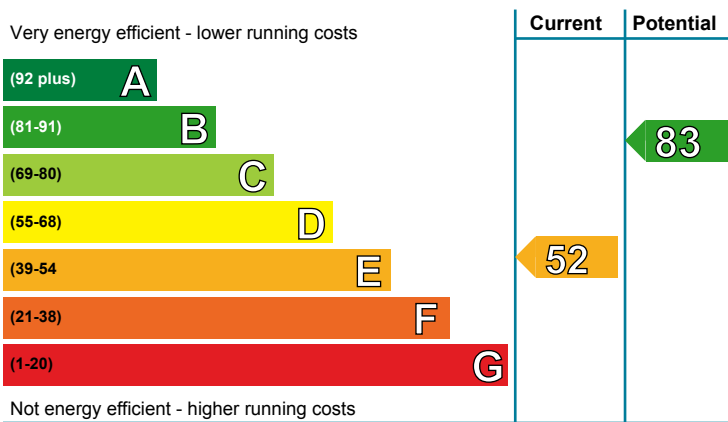
Energy Efficiency Rating

This graph shows the current efficiency of your home, taking into account both energy efficiency and fuel costs. The higher this rating, the lower your fuel bills are likely to be.

Your current rating is **band E (52)**. The average rating for EPCs in Scotland is **band D (61)**.

The potential rating shows the effect of undertaking all of the improvement measures listed within your recommendations report.

Estimated energy costs for your home for 3 years*	£3,510	See your recommendations report for more information
Over 3 years you could save*	£1,467

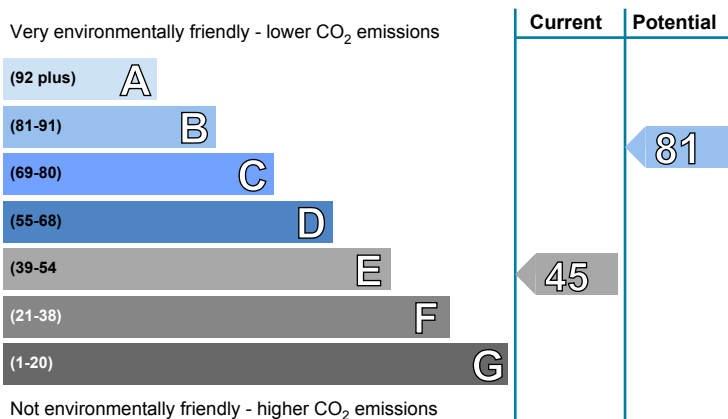
Environmental Impact (CO₂) Rating

This graph shows the effect of your home on the environment in terms of carbon dioxide (CO₂) emissions. The higher the rating, the less impact it has on the environment.
