SINGLE SURVEY REPORT

PROPERTY ADDRESS	64 Willowbrae Road Edinburgh EH8 7HA
CLIENT	The Executry of Alexander Ree
CLIENT ADDRESS	c/o Urquharts 16 Heriot Row Edinburgh EH3 6HR
DATE OF INSPECTION	13 th January 2022
PREPARED BY	DHKK Ltd Chartered Surveyors 54 Corstorphine Road Edinburgh EH12 6JQ Tel: 0131 313 0444 Fax: 0131 313 0555

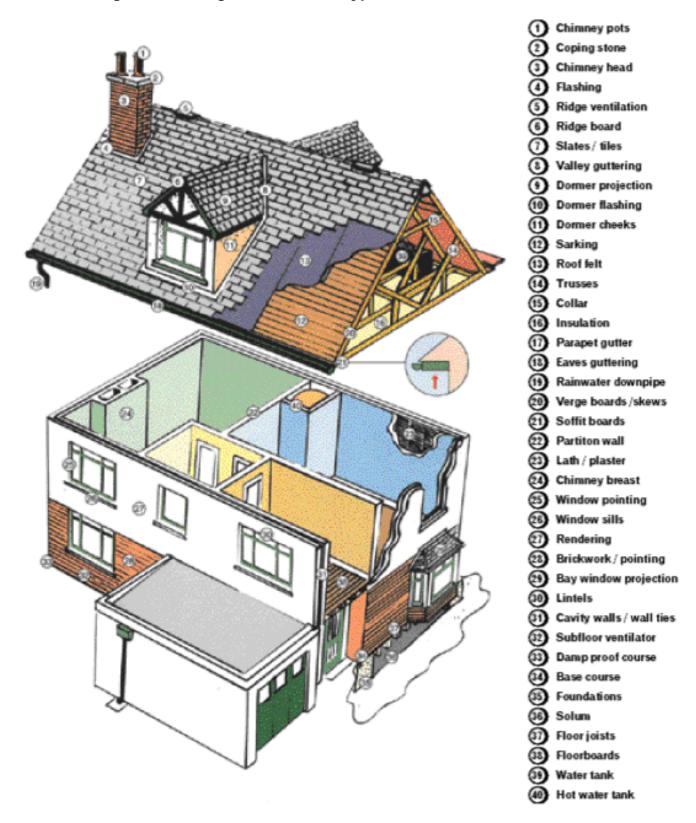
Sectional diagram showing elements of a typical house

Reference may be made in this report to some or all of the above component parts of the property. This diagram may assist you in locating and understanding these terms.
