# HOME REPORT

# Energy Performance Certificate (EPC)

56 RELUGAS ROAD, GRANGE, EDINBURGH, EH9 2LZ

# Single Survey

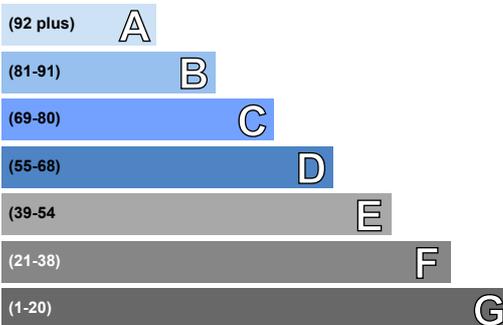
## Environmental Impact (CO<sub>2</sub>) Rating

Current	Potential
65	73

The potential rating shows the effect of undertaking all of the improvement measures listed within your recommendations report.
