Single Survey

Property address	81 Pirniefield Place, Lochend, EDINBURGH, EH6 7PZ
-------------------------	--

Prepared by	ALLIED SURVEYORS SCOTLAND PLC
--------------------	-------------------------------

Date of inspection	31st October 2023
---------------------------	-------------------

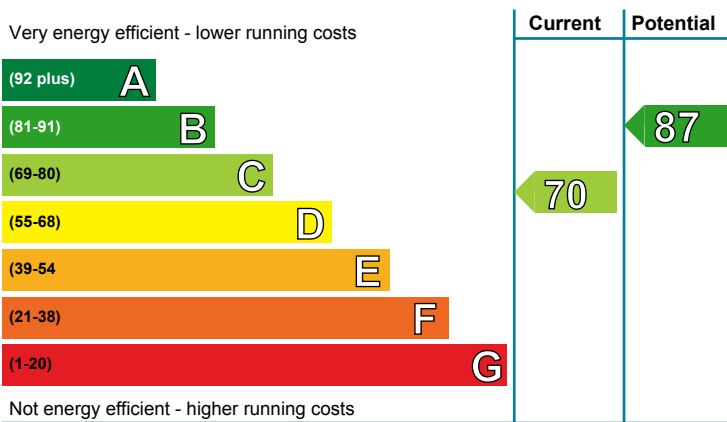
Energy Efficiency Rating

This graph shows the current efficiency of your home, taking into account both energy efficiency and fuel costs. The higher this rating, the lower your fuel bills are likely to be.

Your current rating is **band C (70)**. The average rating for EPCs in Scotland is **band D (61)**.

The potential rating shows the effect of undertaking all of the improvement measures listed within your recommendations report.

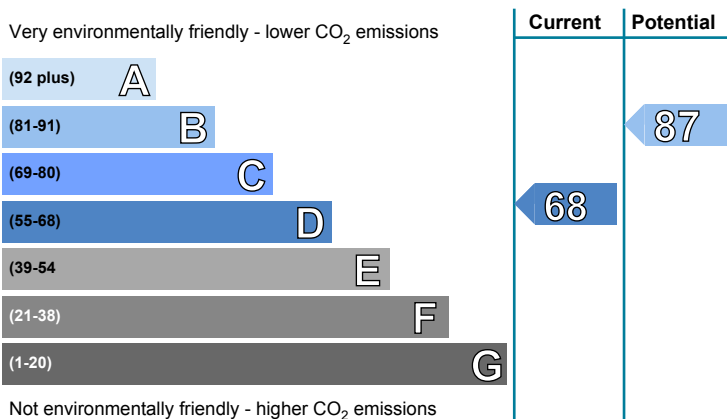
Environmental Impact (CO₂) Rating

This graph shows the effect of your home on the environment in terms of carbon dioxide (CO₂) emissions. The higher the rating, the less impact it has on the environment.

The potential rating shows the effect of undertaking all of the improvement measures listed within your recommendations report.

The average Scottish household produces about 6 tonnes of carbon dioxide every year. Based on this assessment, heating and lighting this home currently produces approximately 2.9 tonnes of carbon dioxide every year. Adopting recommendations in this report can reduce emissions and protect the environment. If you were to install all of these recommendations this could reduce emissions by 1.6 tonnes per year. You could reduce emissions even more by switching to renewable energy sources.
