# Home Report

1F1, 46  
Ratcliffe Terrace  
Newington  
Edinburgh  
EH9 1ST

# Single Survey

<b>Property address</b>	1F1, 46 Ratcliffe Terrace, Newington, EDINBURGH, EH9 1ST
-------------------------	--

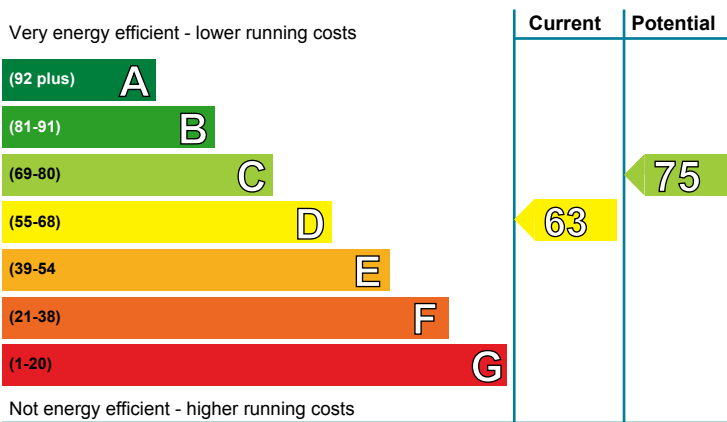
## Energy Efficiency Rating

This graph shows the current efficiency of your home, taking into account both energy efficiency and fuel costs. The higher this rating, the lower your fuel bills are likely to be.

Your current rating is **band D (63)**. The average rating for EPCs in Scotland is **band D (61)**.

The potential rating shows the effect of undertaking all of the improvement measures listed within your recommendations report.
