Home Report

8 /32 Lasswade Road Edinburgh EH16 6RZ

single survey

survey report on:

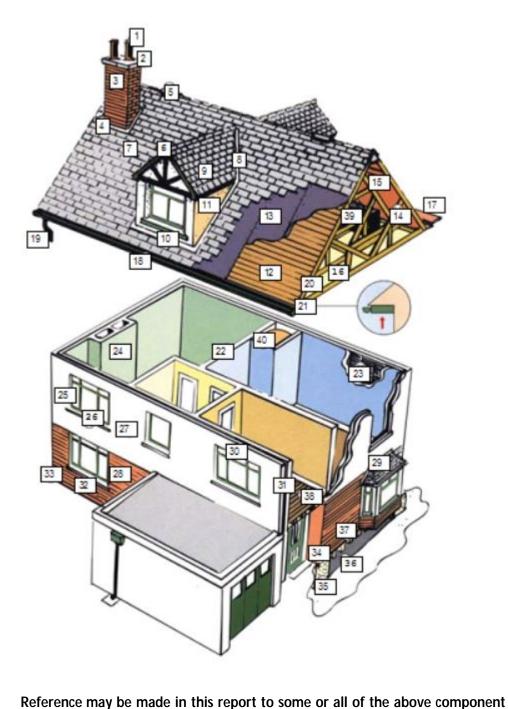
Sectional Diagram showing elements of a typical house

Chimney pots 1 Coping stone 2 3 Chimney head Flashing 4 Ridge ventilation 5 Ridge board 6 7 Slates/tiles 8 Valley guttering 9 Dormer projection Dormer flashing 10 Dormer cheeks 11 12 Sarking Roof felt 13 Trusses 14 15 Collar 16 Insulation 17 Parapet gutter Eaves guttering 18 Rainwater downpipe 19 20 Verge boards / skews 21 Soffit boards 22 Partition wall Lath / plaster 23 24 Chimney breast 25 Window pointing Window sills 26 Rendering 27 Brickwork / pointing 28 Bay window 29 30 Lintels 31 Cavity walls / wall ties Subfloor ventilator 32 33 Damp proof course 34 Base course 35 Foundations Solum 36 37 Floor joists Floorboards 38 Water tank 39 40 Hot water tank parts of the property. This diagram may assist you in locating and understanding
