HOME REPORT

20 REGENT PLACE, ABBEYHILL, EDINBURGH, EH7 5SB

Single Survey

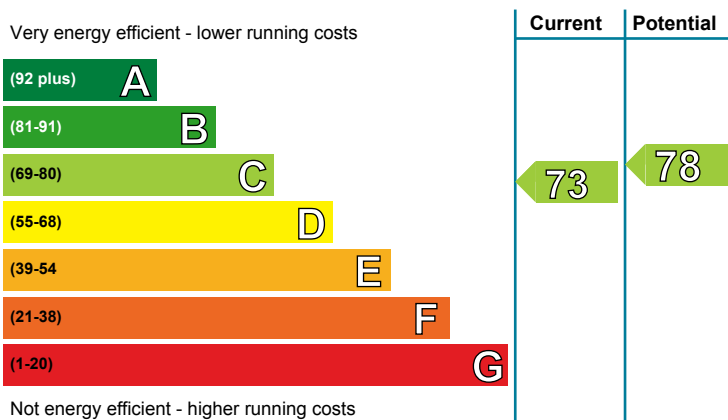
Energy Efficiency Rating

This graph shows the current efficiency of your home, taking into account both energy efficiency and fuel costs. The higher this rating, the lower your fuel bills are likely to be.

Your current rating is **band C (73)**. The average rating for EPCs in Scotland is **band D (61)**.

The potential rating shows the effect of undertaking all of the improvement measures listed within your recommendations report.

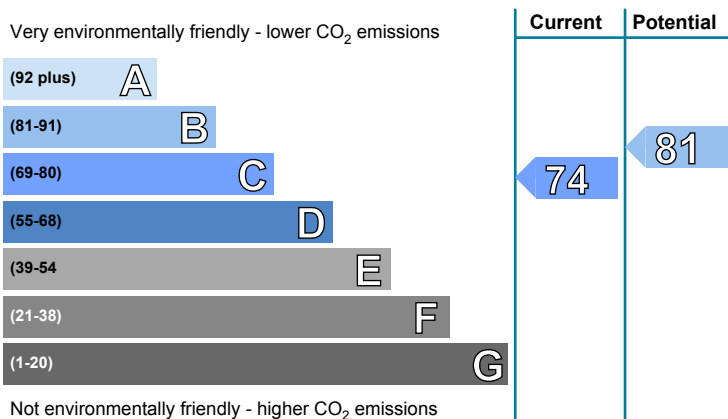
Environmental Impact (CO₂) Rating

This graph shows the effect of your home on the environment in terms of carbon dioxide (CO₂) emissions. The higher the rating, the less impact it has on the environment.

Your current rating is **band C (74)**. The average rating for EPCs in Scotland is **band D (59)**.

The potential rating shows the effect of undertaking all of the improvement measures listed within your recommendations report.
