# Home Report

Ardochart

# Single Survey

<b>Property address</b>	Ardochart, Bearford, HADDINGTON, EH41 4LB
-------------------------	--

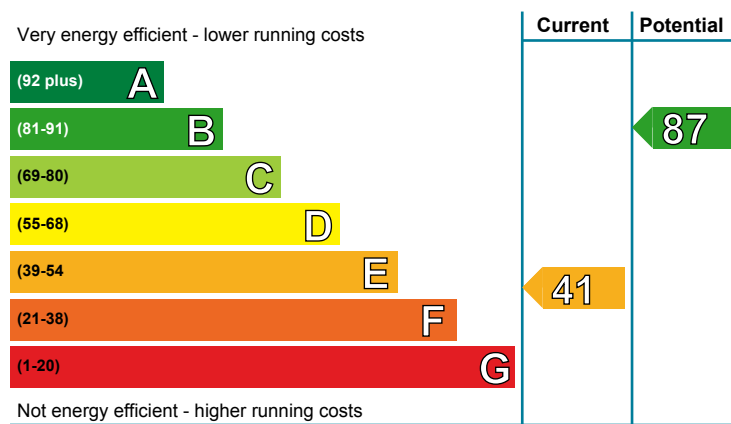
## Energy Efficiency Rating

This graph shows the current efficiency of your home, taking into account both energy efficiency and fuel costs. The higher this rating, the lower your fuel bills are likely to be.

Your current rating is **band E (41)**. The average rating for EPCs in Scotland is **band D (61)**.

The potential rating shows the effect of undertaking all of the improvement measures listed within your recommendations report.
