## **SINGLE SURVEY REPORT**

**7 THORNVILLE TERRACE  
LEITH LINKS  
EDINBURGH  
EH6 8DB**

**23<sup>RD</sup> APRIL 2024**

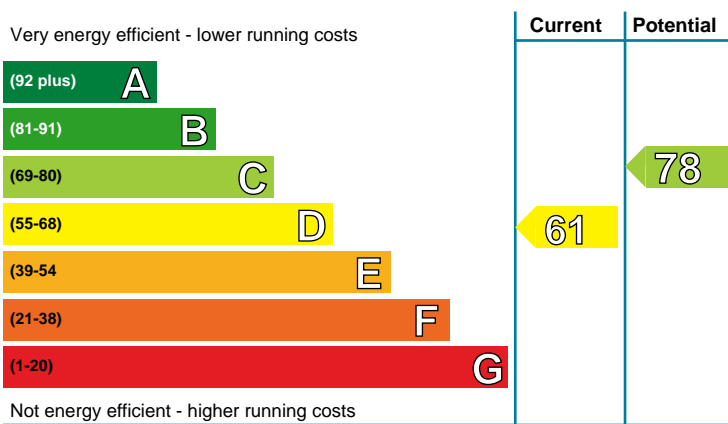
## Energy Efficiency Rating

This graph shows the current efficiency of your home, taking into account both energy efficiency and fuel costs. The higher this rating, the lower your fuel bills are likely to be.

Your current rating is **band D (61)**. The average rating for EPCs in Scotland is **band D (61)**.

The potential rating shows the effect of undertaking all of the improvement measures listed within your recommendations report.
